Evaluation Report 234

International Harvester Model 425 Baler

INTERNATIONAL HARVESTER MODEL 425 BALER

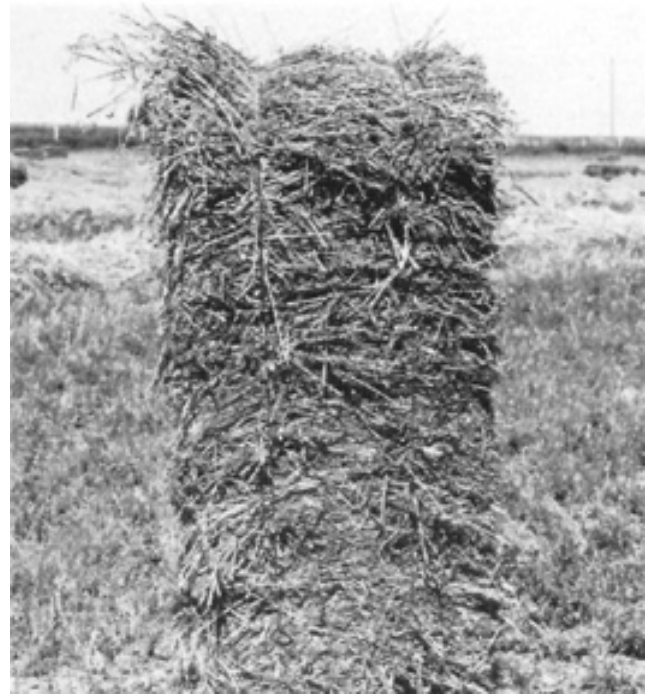
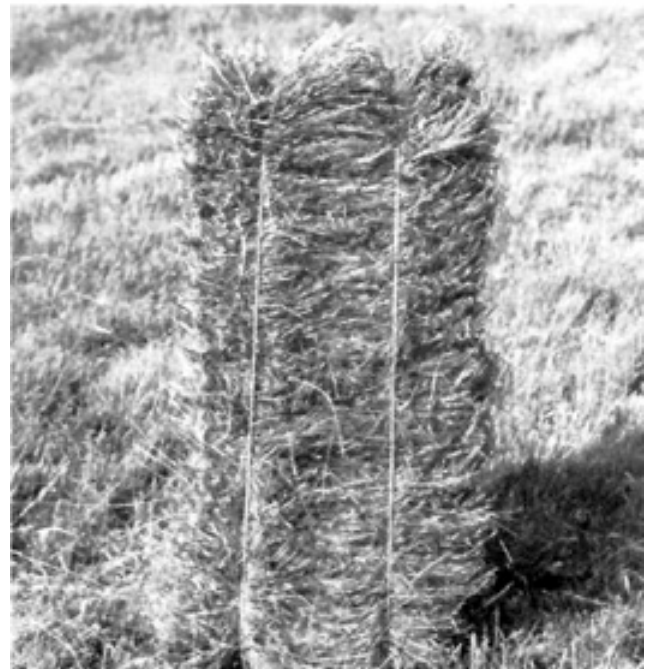
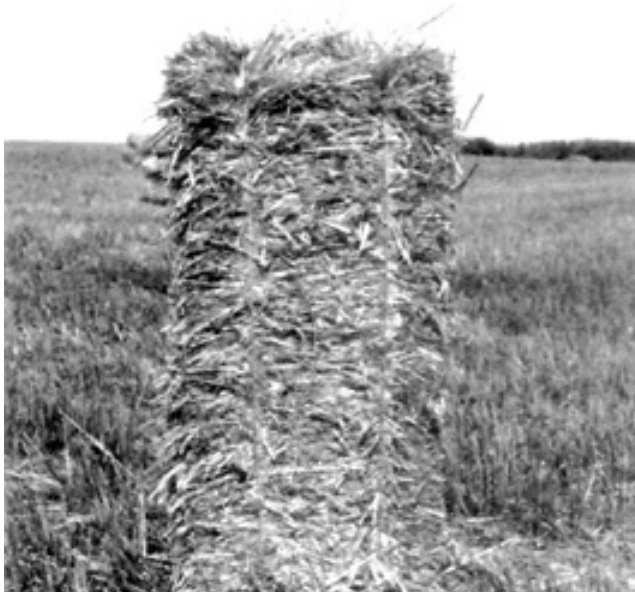
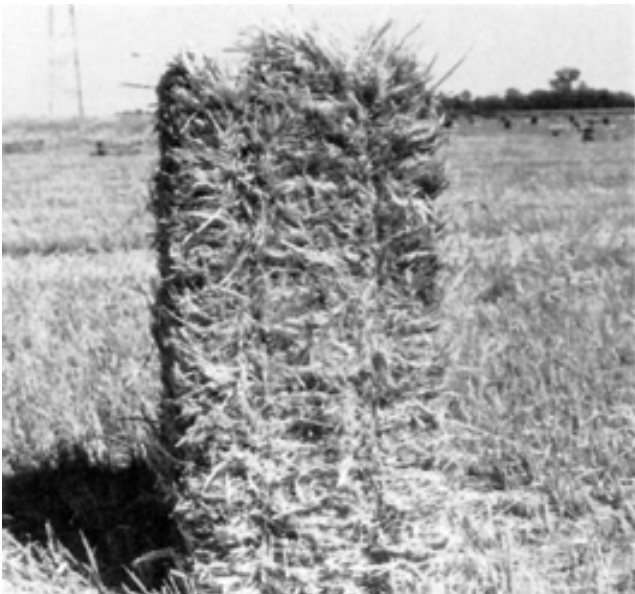
Bale Quality: The International Harvester 425 was capable of producing firm, durable bales in most crops (FIGURE 2). Bale chamber density adjustment was inadequate to form dense bales in short stemmed or very dry crops. In these conditions, the bales were poorly formed and of inadequate durability for bale wagon handling (FIGURE 3). Average hay bales weighed 22 to 34 kg (48 to 75 lb), while average straw bales weighed 18 to 23 kg (40 to 51 lb). Average bale density varied from 143 to 200 kg/m³ (8.6 to 12.0 lb/ft³) in hay and from 103 to 141 kg/m³ (6.2 to 8.5 lb/ft³) in straw.

FIGURE 2. Typical Bales: (A) Alfalfa, (B) Bromeegrass, (C) Greenfeed, (D) Straw.

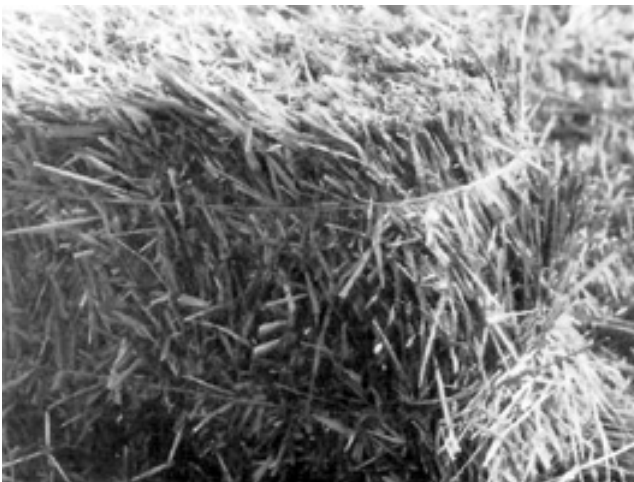
FIGURE 3. Poorly Formed Bale due to Inadequate Density Adjustment.

For most crops, the hand cranks provided insufficient adjustment range to produce dense bales unless additional bale wedges were installed in the bale chamber. The bale chamber had holes for installation of two sets of bale wedges. To obtain an adequate range of bale density adjustment, it was necessary to drill holes and install a third set of wedges. In dry conditions or very light windrows, the adjustment range, even with three sets of bale wedges installed, was insufficient to produce firm, durable bales suitable for bale wagon handling (FIGURE 3).

Modifications to the bale chamber density adjustment to improve bale density and durability.

Only the top tension bar of the International Harvester 425 was adjustable. Most conventional balers involve both top and bottom tension bars in the bale density adjustment. In addition, the bale chamber length was about 130 mm (5 in) shorter than most comparable North American balers. It is recommended that the manufacturer consider modifications to the bale chamber density adjustment to improve bale density and durability.

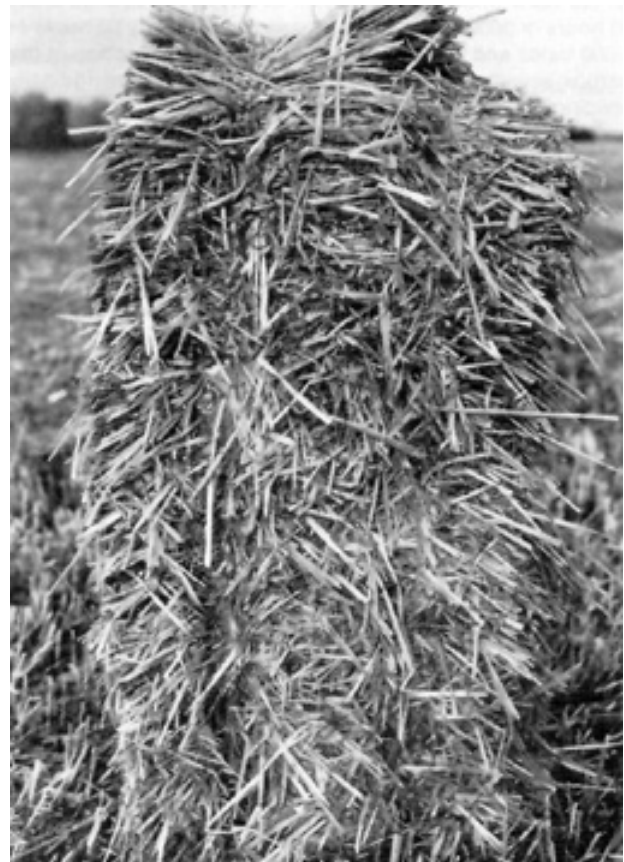
Feeding System: The packer fingers had three settings which were adequate to provide well formed bales in most crops. However, in very dry greenfeed, packer finger adjustment was inadequate to produce well formed bales (FIGURE 7). The packer fingers were easily adjusted with a wrench.

FIGURE 7. Poorly Formed Bale in Greenfeed due to Inadequate Packer Finger Adjustment.

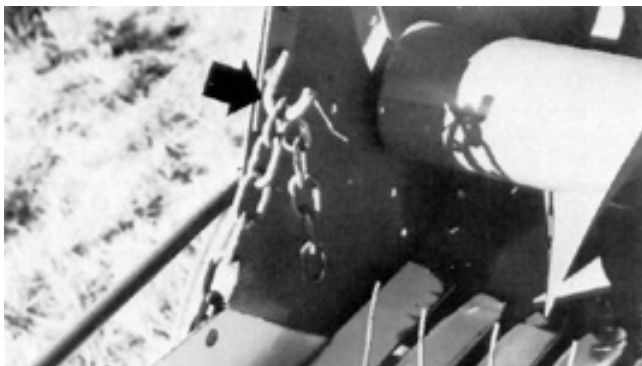
Pickup: The pickup height was easily set by positioning the chain on the hook (FIGURE 8). The pickup gauge wheel was positioned with the use of wrenches. The pickup windguard was not adjustable.

FIGURE 8. Pickup Height Adjustment.
